Derailment of XPT ST23

Wallan, Victoria on 20 February 2020

ATSB Transport Safety Report

RO-2020-002

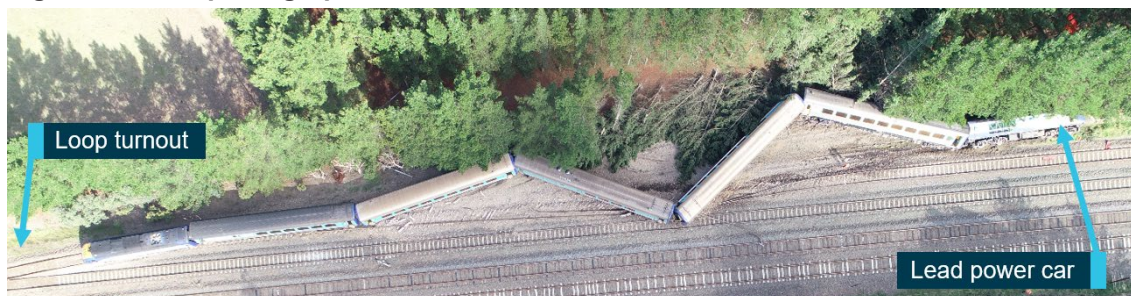
Figure 3: Aerial photograph of derailment site

At about 1943, ST23 was approaching the northern end of Wallan Loop at about the track's line speed. A brake application was made a short distance before the turnout, probably between 50 and 153 m from the points. This slowed the train a small amount before it entered the turnout travelling at a speed probably between 114 and 127 km/h. The train was not able to negotiate the turnout to the crossing loop track at this speed and derailed. The leading power car rolled onto its left side. All vehicles derailed excepting the rear power car (Figure 3).

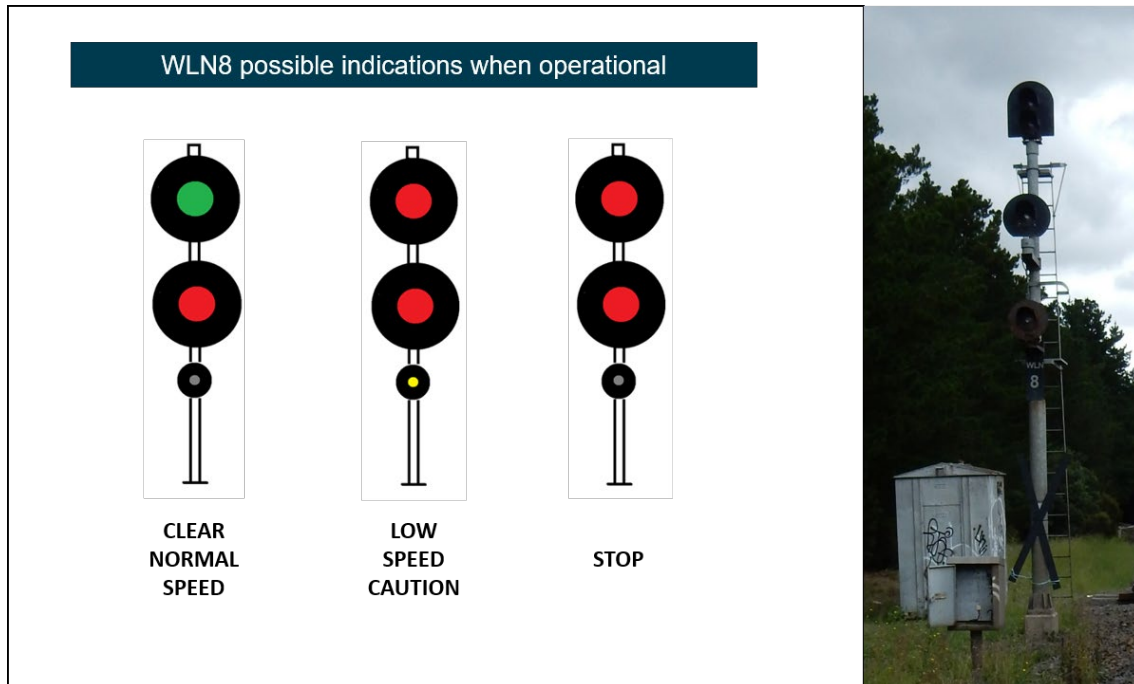
Figure 7: Signal WLN8 possible indications (left) and on day of occurrence (right)

At the time of the derailment, signal WLN8 was extinguished and was fitted with a black cross near its base to indicate that it was not functioning (Figure 7).

The figure shows the possible indication for signal WLN8 (when operational), and a photograph of the signal extinguished on the day of the occurrence. The photograph of signal WLN8 also shows the black cross that was attached to the signal post.
Source: CITS

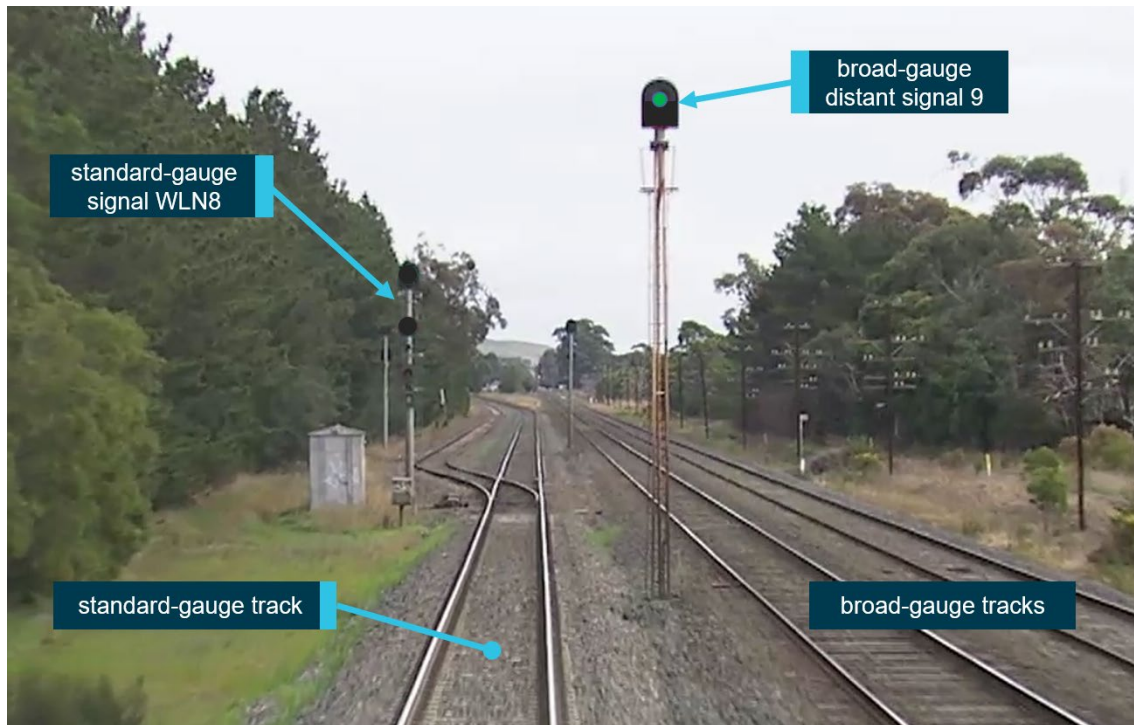
Figure 8: The tracks and signalling at the northern end of Wallan Loop

A broad-gauge distant signal was located about 45 m to the north of WLN8 and was probably indicating a Proceed (green) aspect at the time ST23 passed (Figure 8).³⁹ This broad-gauge signal did not apply to the operation of ST23 that was running on the standard-gauge line.

The photograph shows the approach to the Wallan Loop turnout. The photograph has been modified to show the extinguished state of standard-gauge signal WLN8 and the probable Proceed (green) indication of broad-gauge distant signal at the time of the derailment. The black cross that was fitted near the base of signal WLN8 at the time of the derailment is not shown in this figure. Source: V/Line training video, with signal indications modified and annotated by CITS

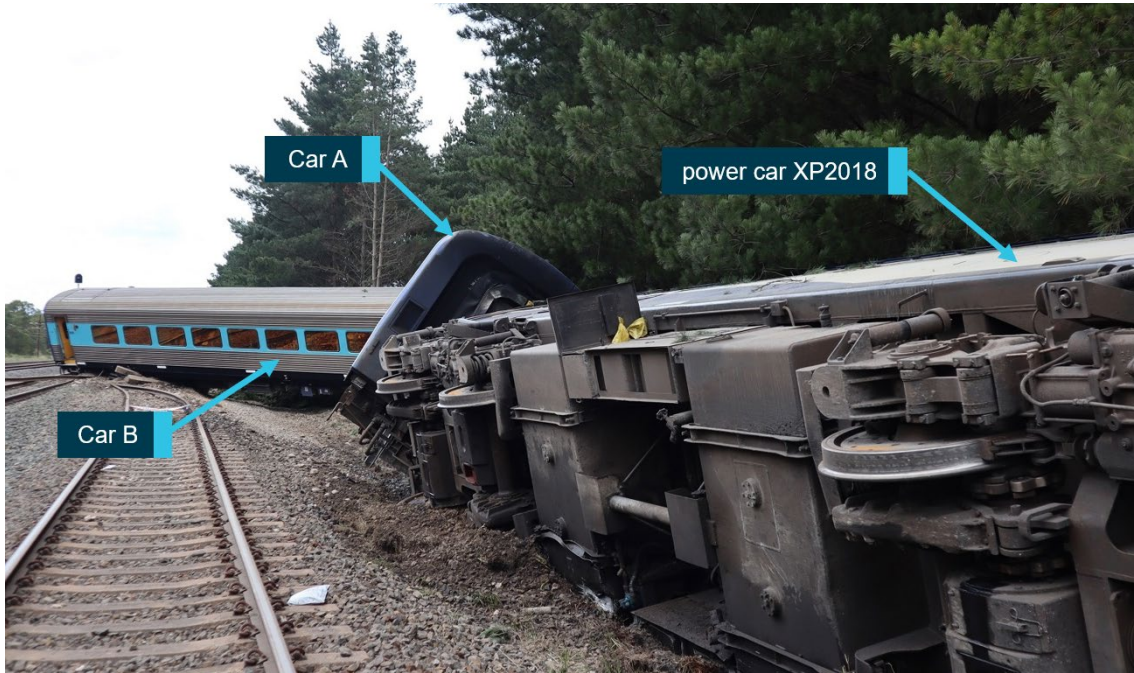
Figure 9: Leading three vehicles in the derailment

The derailed train came to rest in a concertinaed arrangement. The lead power car had rolled onto its left side and decelerated at a higher rate than trailing vehicles (Figure 9).

The photograph shows power car XP2018 on its left side, and first two passenger cars A and B.
Source: CITS

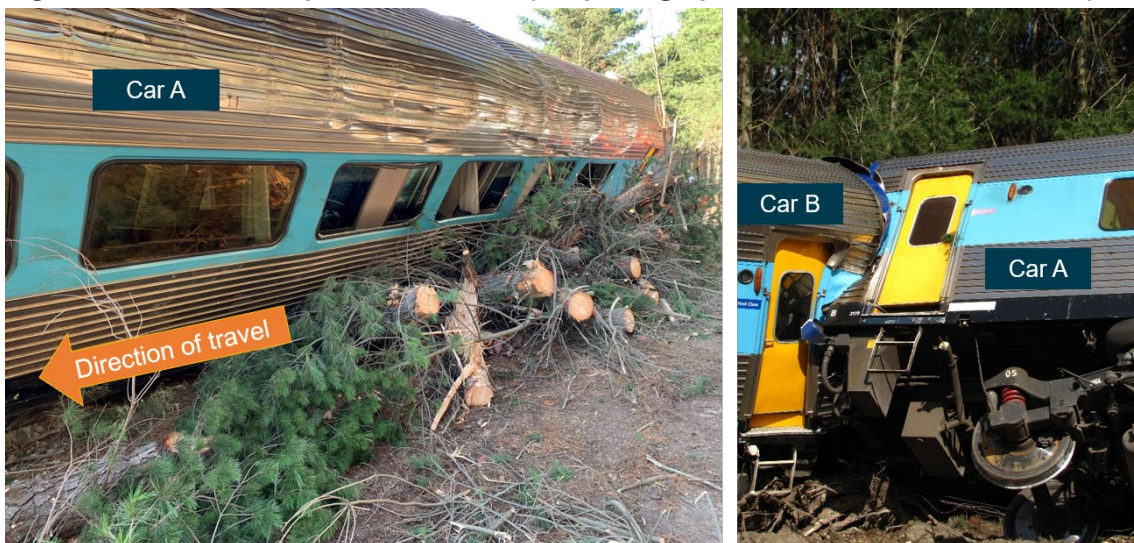
Figure 10: The derailed position of Car A (left photograph taken after removal of trees)

Of the passenger cars, the first (Car A) had the greatest tilt of about 30 degrees from the vertical. It had come to rest on a row of pine trees and its trailing end had bound with the next car, Car B (Figure 10). The row of pine trees had probably stopped Car A from rolling onto its side.

The left photograph shows Car A rolled to its left and supported by pine trees, and the right photograph shows the trailing end of Car A bound with the leading end of the next car, Car B.
Source: CITS

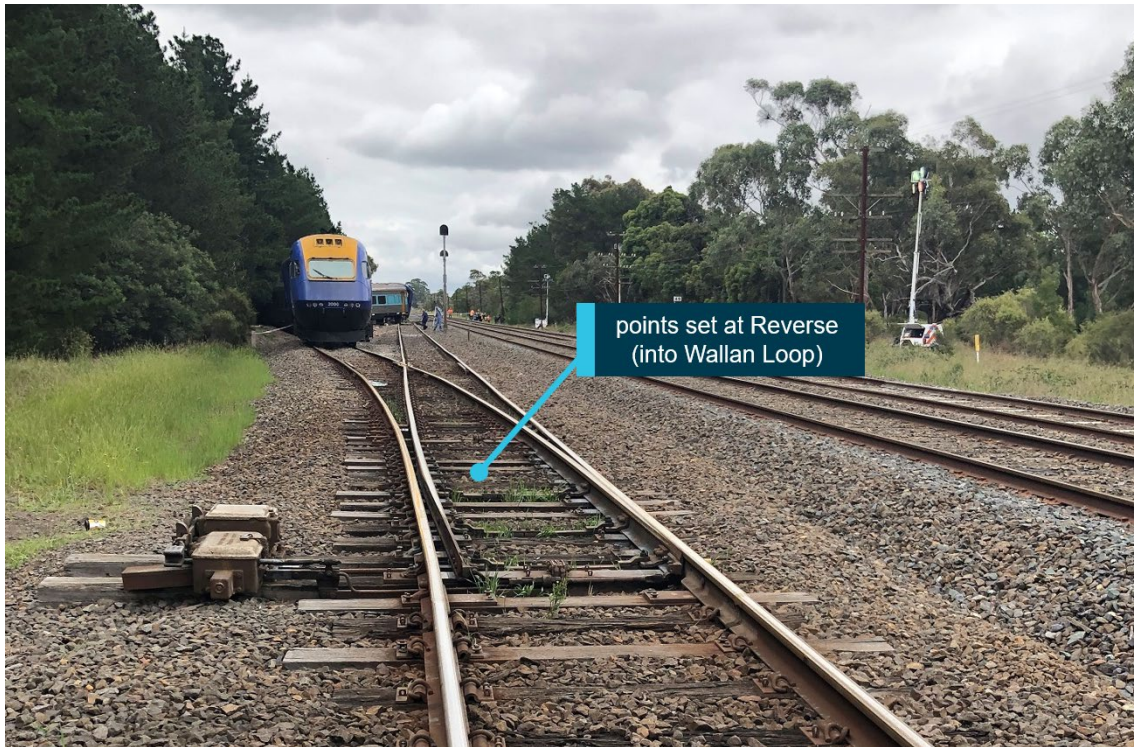
Figure 11: No. 7 points at the northern entrance to Wallan Loop

There were a number of witness marks on rails and within the track that indicated that wheels had derailed within the turnout. There were no derailment marks identified prior to the turnout.

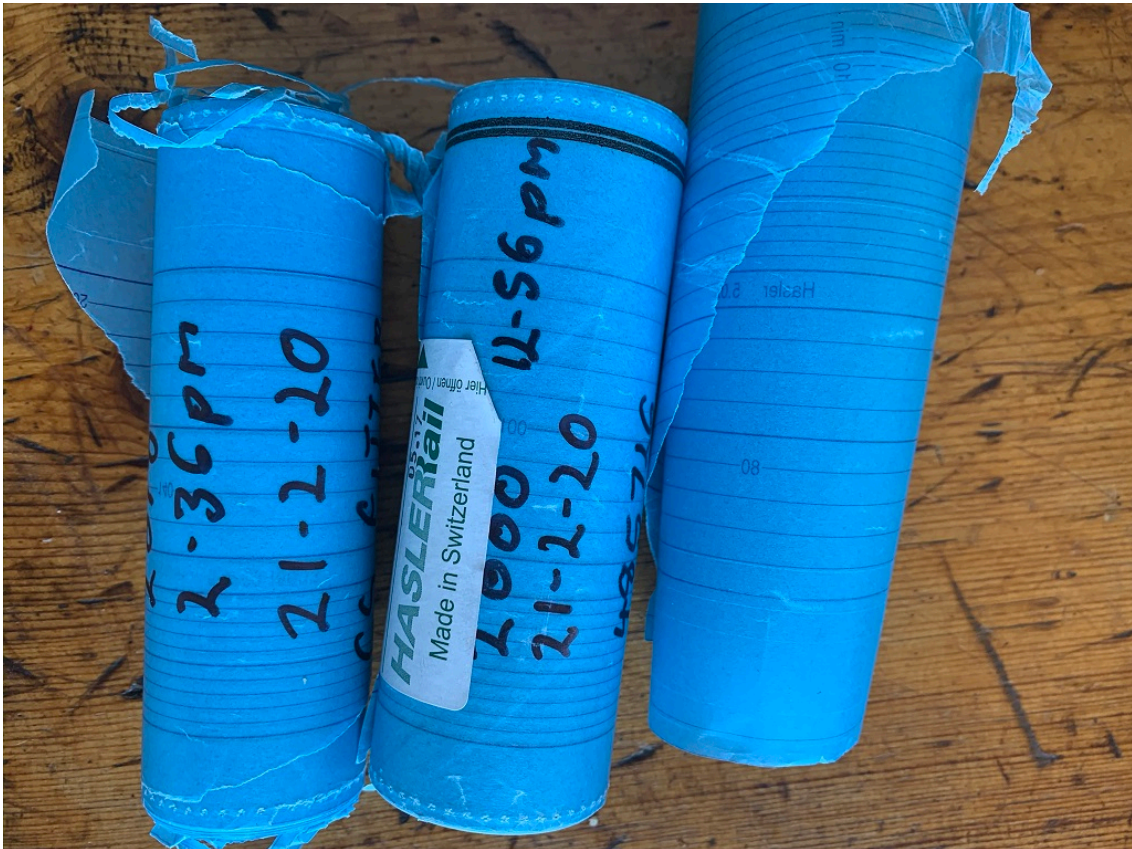
Figure 12: Hasler waxed paper rolls removed from power cars XP2018 and XP2000

The Hasler tapes from the two power cars were recovered for analysis (Figure 12). During retrieval, the Hasler tape from XP2018 jammed in the recorder and was damaged. However, all information was recovered and data relevant to the investigation was not affected.

The photograph shows the recovered waxed tapes. The centre roll is the tape from power car XP2000. The left and right rolls are the tape from power car XP2018 that jammed and was torn at one location.
Source: CITS

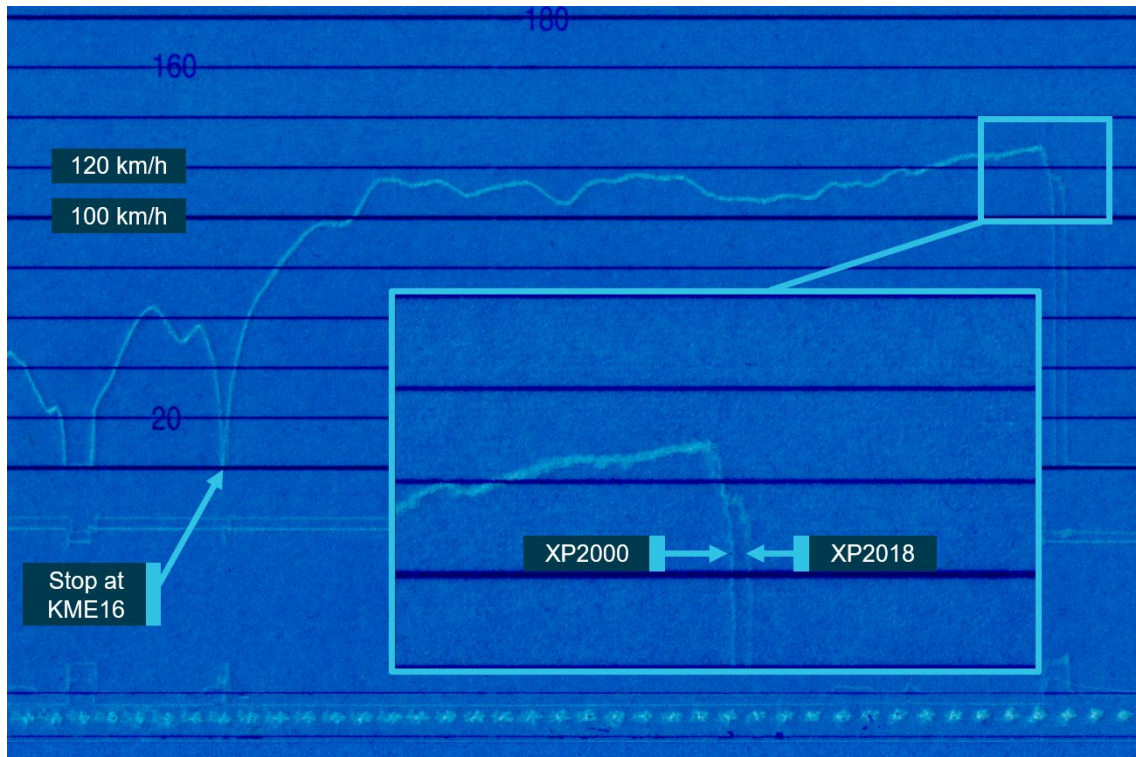
Figure 13: Overlay of data recordings from XP2018 and XP2000

An initial review identified a likely recording anomaly in the latter part of the XP2018 data. All channels recorded noise in the latter phase. An overlay of the data from the two power cars showed the discrepancy (visible as diverging speed toward the end of the data) and also confirmed that the speed data prior to this occurring was consistent (Figure 13).

The image shows an overlay of speed records from power cars 2018 and 2000. It indicates consistent speed records after departing Kilmore East, then a consistent initial sharp deceleration of both cars followed by diverging speed records during the derailment. Source: ST23 Hasler recordings annotated by ATSB

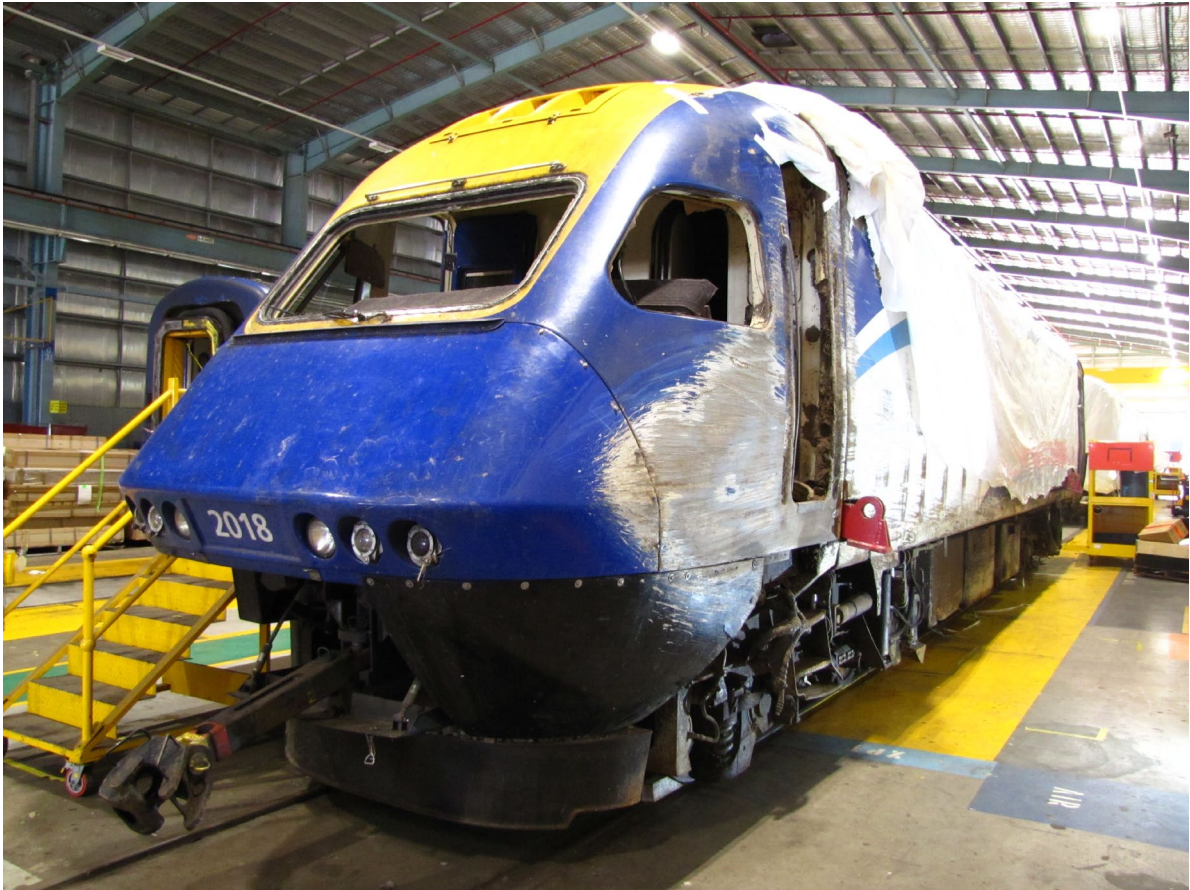
Figure 14: Power car XP2018 at Auburn workshops 10 March 2020

Damage to the vehicle's exterior indicated that the lead power car had slid on its side for some distance (Figure 14). The driver's cab retained its structural integrity. However, the left-side cab door separated from the door frame, and the left-side engine room door at the rear of the power car was dislodged. Fuel tanks on the left side were also breached.

Internally within the cab, equipment and fittings remained mostly intact. Instruments, control panels and interior linings contained little or no damage. The driver's side (left-side) headrest was detached from the seat back.

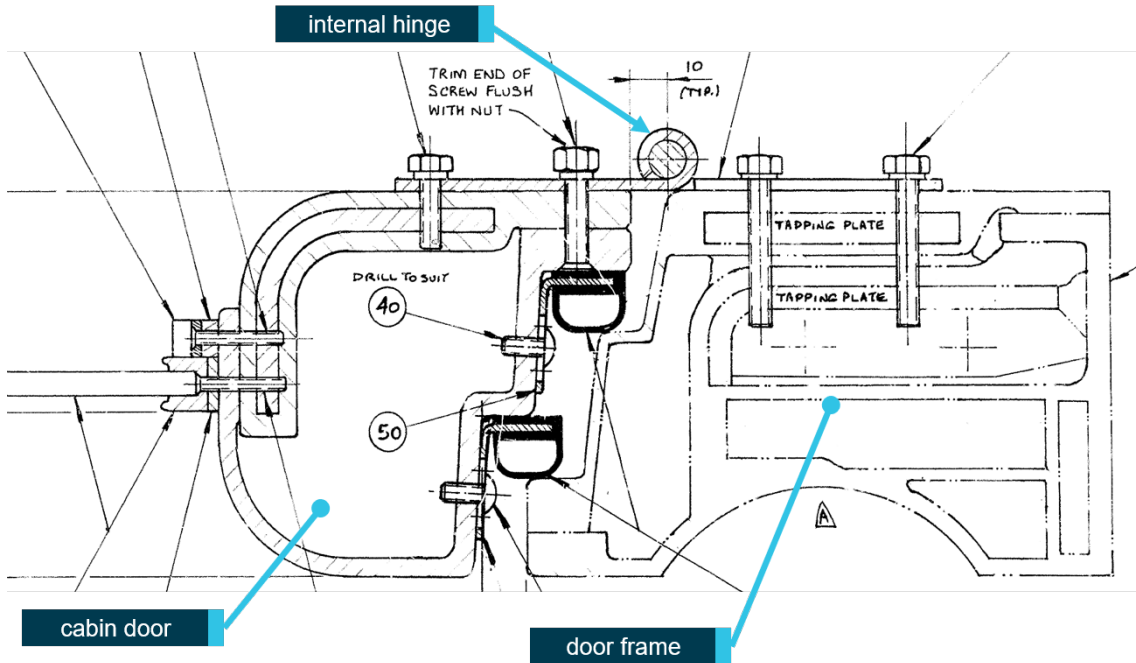
Figure 15: Door and doorframe section drawing

The most significant damage to the power car was to the left cab entry door. The cab door had been secured with two hinges on its rear edge and a single door latch on its forward edge. The glass fibre composite doors were a plug shape and rotated inward on the rear door frame. The hinges were attached to the door and frame using bolts secured to embedded plates (Figure 15).

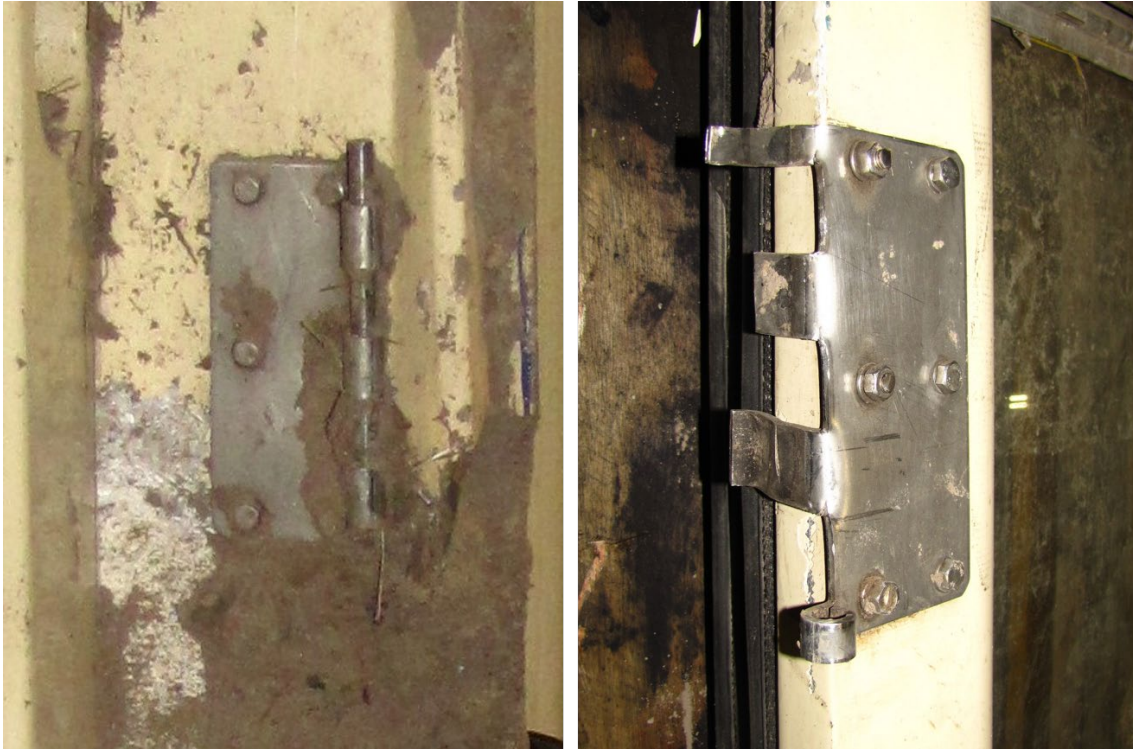
Figure 16: Upper internal hinge of left cab door of XP2018

The door hinges had failed as a result of the external loading during the sliding event. The door had become disconnected from the door frame and loose within the cabin. The door-side fingers of the upper hinge had peeled open (Figure 16) and the lower hinge had failed by the loss of fastening on the frame-side of the hinge (Figure 17).

With the door aperture open, the rear of the door frame had acted as a scoop for ballast and dirt which accumulated inside the cab. A significant amount of material was found to have entered the cab space.

The left cab door of the power car did not withstand the external loading associated with power car 2018 rolling on to its side. This resulted in materials entering the driver’s cab of the power car.

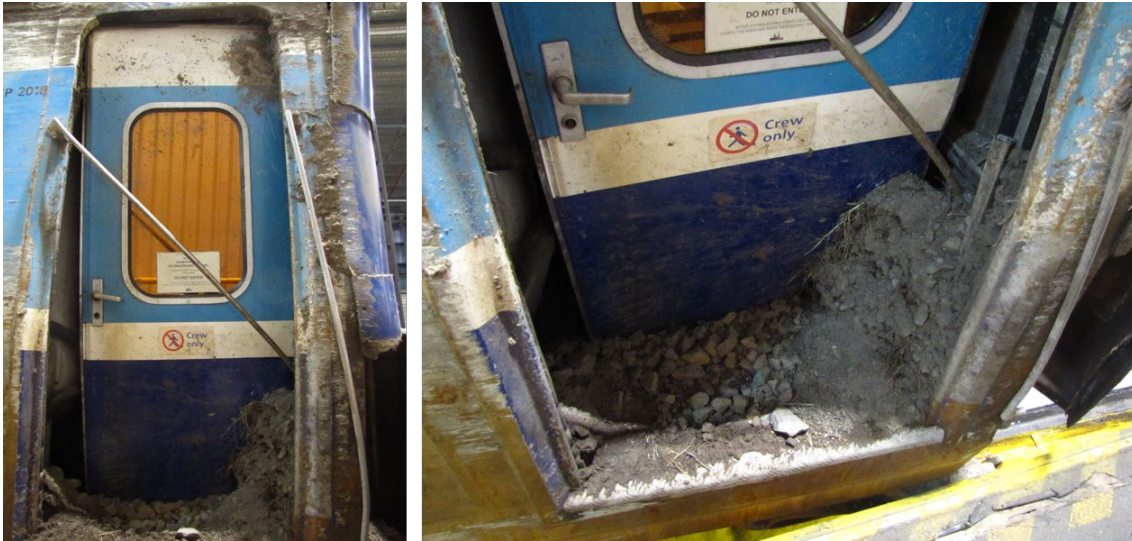
Figure 18: The rear left-side door of power car XP2018

The rear external machinery space entry door on the left side of the power car had also been dislodged but the top hinge did not fully part from the frame (Figure 18). There was a build-up of ballast and dirt at the base of the door.

The left photograph shows a full view of the rear left-side door of XP2018, and the right photograph the base of the door pushed-in by track ballast and dirt.
Source: ATSB

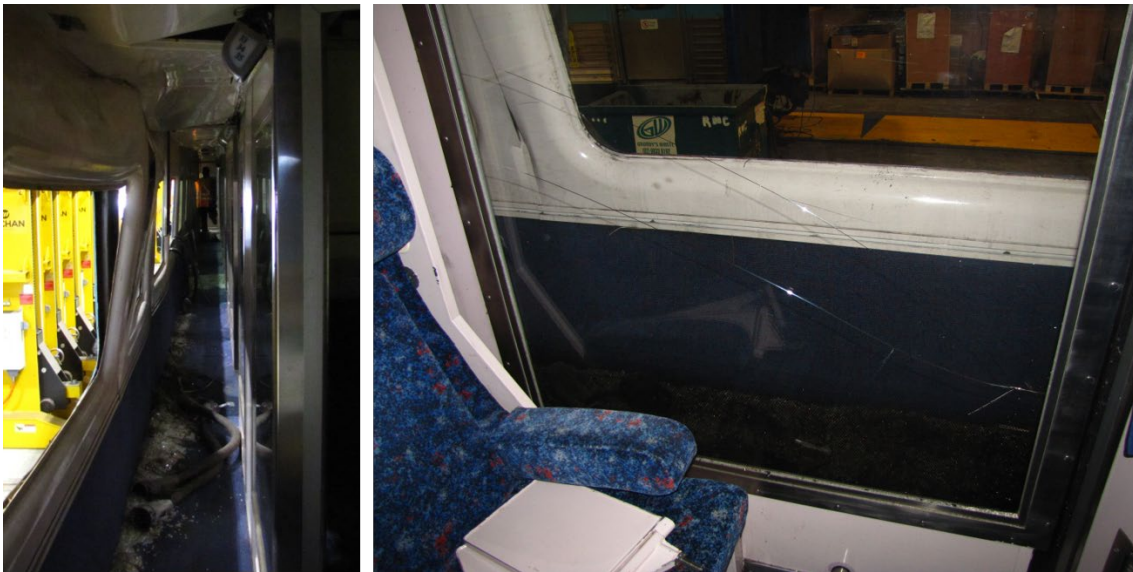
Figure 19: Passenger car A, left-side corridor (left) and fractured glass partition (right)

Damage within the sleeper car included collapsed interior lining in the passenger aisle. Two cabins had cracked glass partitions most likely from being struck by luggage or passengers (Figure 19).
